# Sandberghof

## Umbau und Sanierung mit Lehmbaustoffen am Beispiel

## Sandberghof – conversion and renovation using earthen building materials

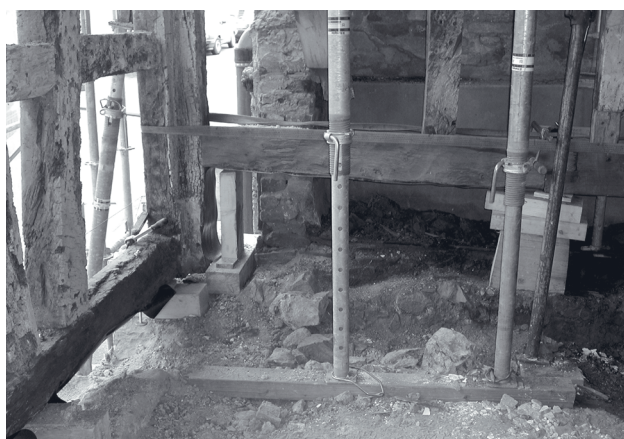
Das Fachwerkhaus wies alle typischen Schäden der Holzkonstruktion auf: verfaulte Schwellen und Brüstungsriegel, Deckenbalken, Rähme, Sparren mit Wurmfraß. Dazu war das Sockelmauerwerk wegen fehlender Fundamente gekippt und hatte die Schwellen nach außen gezogen. Die Strohlehmgefache der Außen- und Innenwände, sowie Decken dagegen waren relativ gut erhalten. Bei der ursprünglichen Nutzung als Remise o.ä. gab es im Obergeschoß keine Innenwände, Wände und Decken waren innen und außen balkensichtig, die Lehmgefache wie üblich mit dünnem Kalkputz versehen und weiß bzw. farbig über die Balken hinweg kalkgetüncht. Wenig später wurde das Haus in Wohnungen unterteilt, ebenfalls mit Lehmfachwerkwänden. Der südliche Hausteil, früher Scheune, hat Bruchsteinaußenwände, die Zwischenwände aus Ziegeln und die Einschubdecken aus Lehm waren nochmal später, bei einem weiteren Ausbau zu Wohnungen eingezogen worden. Nun wurde außen und innen das Fachwerk überputzt, innen mit farbiger Schablonenmalerei gefasst. Lehmputze sind in der Region nicht üblich und waren auch hier nicht zu vorzufinden.

The half-timbered building exhibited a whole host of typical timber defects: rotten sole-plates, window sills, ceiling joists and cross rails as well as rafters suffering from woodworm. The lack of a foundation had caused the plinth walling to tilt, pushing the sole-plates outwards. The wattle-and-daub infill on the exterior elevations and in the interior walls and ceilings were, however, in a fairly good condition. In its original use as an outbuilding there had not been any separating walls in the upper storey and the walls and ceilings were flush with the timber framing on the inside and outside. The infill panels had been given a thin coat of lime plaster and painted or whitewashed along with the timber frame. At a later date, the building had evidently been divided into flats, again using half-timbered straw-clay walling. The southern section of the building, previously a barn, has rubble masonry walling: later internal brick walls and an earth-filled timber-panelled ceiling were added when it was converted to a dwelling. The outside and inside of the timber-frame had been plastered over and given a stencilled decorative border. Clay plasters are not typical for this region and were not found anywhere in the building.

1 Zustand vor der Sanierung.  
Condition prior to renovation works.

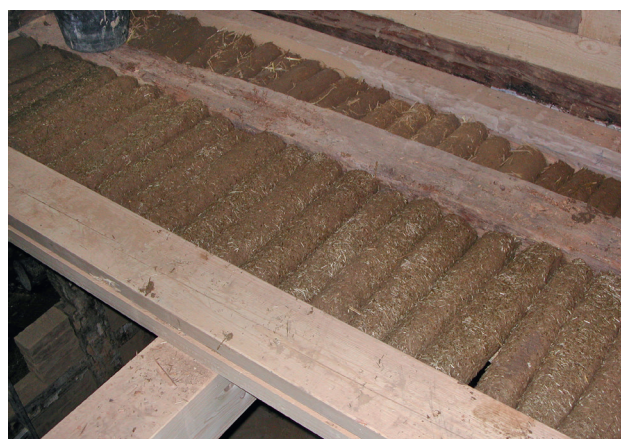
6 Herstellung der Lehmwickel.  
Manufacture of the "earth reels".

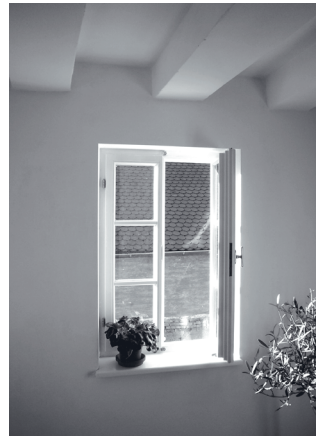
8 Durch die Innendämmung werden die Proportionen des barocken Fachwerkhäuses sowie fachwerktypischen Details bewahrt.  
The internal insulation meant that the original proportions as well as characteristic details could be maintained.
