## Die Überschwemmung von Sandema im September 2007 – Auswirkungen auf Lehmbauten

## The Sandema floods in September 2007 – its effects on earth buildings and ways forward

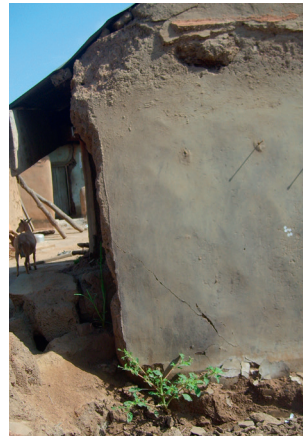
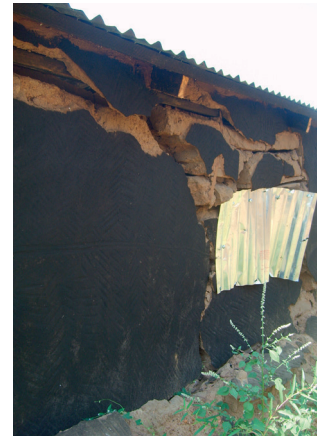
3 Neubauten in niedrig liegenden Gebieten von Sandema  
New buildings in a low lying area in Sandema

The desire for fertile farmlands has forced people to settle in low lying grounds with the intention of getting enough water for their crops. However, changes in the weather pattern have made such areas susceptible to unpredicted weather behaviour. These residents suffer whenever there are floods. Fig. 3 shows new settlements recently constructed in a low lying river basin used for the cultivation of rice in Sandema Township. Building in such potentially dangerous areas is partly due to the non-enforcement of town and country planning zoning by the local administration.

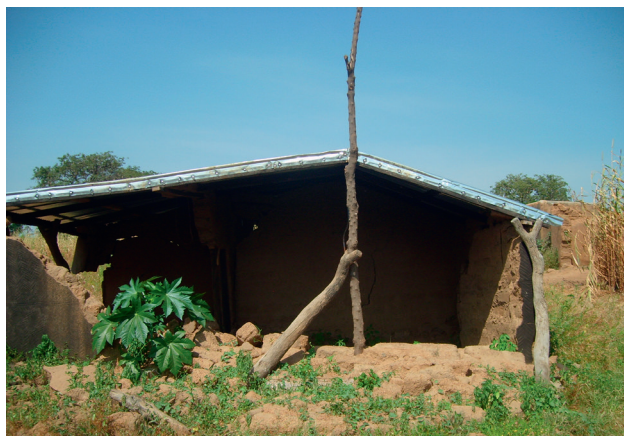
- *Fehlende Fundamente:* Die meisten der gegenwärtigen Lehm-bauten haben keine richtigen Fundamente. Wände werden auf dem Boden errichtet, der vom Mutterboden befreit wurde. Die erste Wandschicht aus unstabilisiertem Lehm wird auf diesem Streifen eingebracht. Natürlich bietet ein solch niedriges Fundament eine Angriffsfläche am Wandfuß für Spritz- und Fließwasser. Letzteres vor allem sorgte für eine schnelle Erosion der Wand [7] (Abb. 4).

- *Non-existence:* Most earth buildings identified in the area did not have proper foundations for the walls. The walls were built into the ground by clearing the top soil with a hoe to a depth of about 50 mm after which the first course of unstabilised material is laid. These shallow foundations proved very susceptible to erosion by surface run-offs and stagnant waters. This weakened the foundations of such buildings and ultimately led to their collapse. When the flood waters flowed against such weak foundations and wall bases, its speed and turbulence eroded the base of the building. [7]

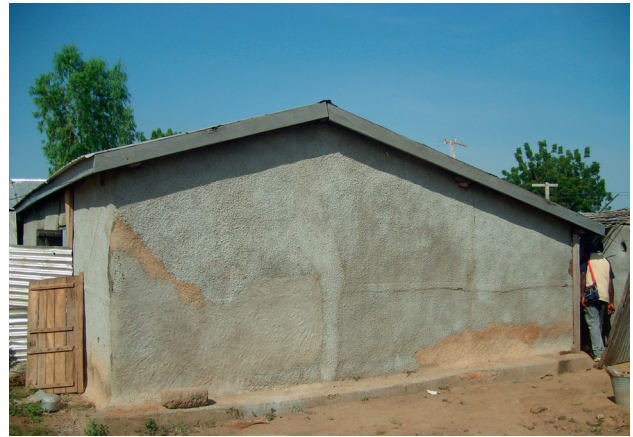
Das Flutwasser erreichte eine Höhe von ca. 1,5 m. Der Wasserdruck auf die Wände führte zum Zusammenbruch. Dazu kamen noch die Schäden der durch das Flutwasser mitgerissenen Trümmer-teile [7] (Abb. 6).

The flood water rising up to 1.5 m exerted a lot of stresses on the walls leading to their collapse through pressure differences. In addition further damage resulted from the impact of objects from the movement of debris in the floods from upstream. [7]

6 An der Ecke zerstörtes Lehmhaus  
An earth building damaged at the junction
