## Transfer and renovation of one of the last remaining houses with a 'podsíň' in the Czech Republic

Relocation of a wall segment of unburnt bricks in two compact blocks

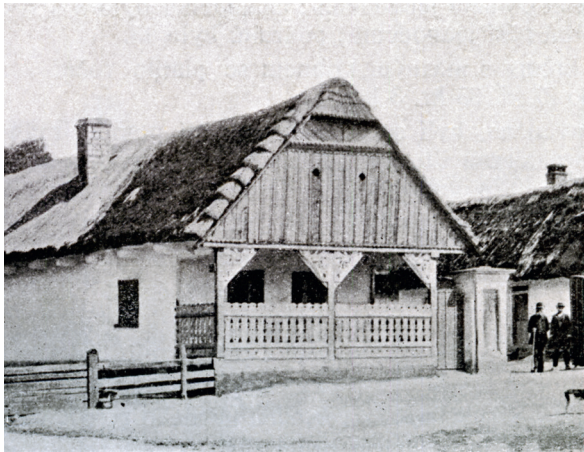
A photo published in 1909 shows the oldest known shape of the building (Fig. 1). A house of traditional three-part disposition with adjacent farming segment is situated at the north part of the yard. The photo documents the original collar beam roof with extending visible ceiling beams above the 'zápraží' and a saddle roof with thatched roofing. The timbered

part is depicted already in the 'fur-coat', the bricked part is plastered. Under the extended roof with regionally distinctive gables ('lomenice') topped with 'kabřinec', the 'podsíň' with decorative fence and fillings between struts and columns is situated.

Fig. 1 House No. 65 in Oskořínek with the "Podsíň" – oldest known photograph in a book from 1909.

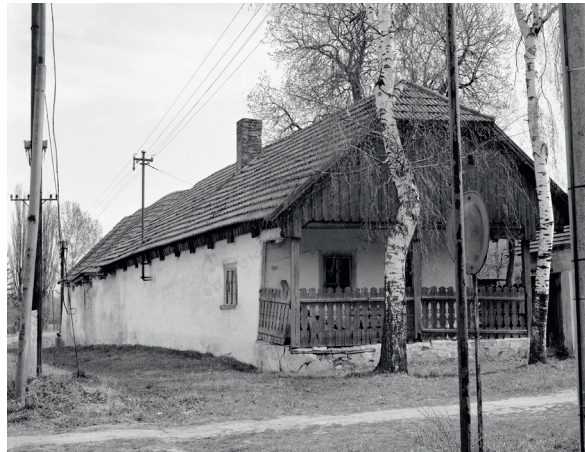
The status after the adjustments from the 1st half of the 20th century is illustrated by the photo documentation from 1986, which still shows adjacent farming segment (Fig. 2). The saddle roof with burnt roofing is supported by the purlin roof frame with exceeding profiled endings of the rafters. The front parts of the shortened extensions of ceiling beams are covered with wood panelling from vertically laid planks. The 'lomenice' was changed for trapezoidal vertically panelled gable, while 'kabřinec' was replaced by hipped gable. Decoratively profiled fillings between the struts and columns of 'podsíň' had not survived until then.

Fig. 2 House No. 65 in Oskořínek with the "Podsíň", 1986

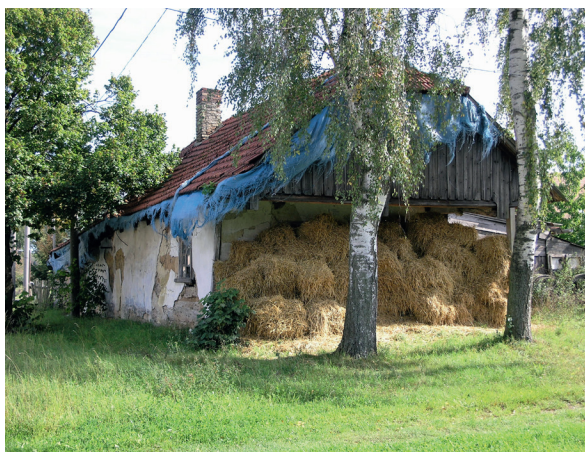
The State Monument Care in the Czech Republic prefers preservation and renovation of listed monuments 'in situ'. In case of the over a long term unused and neglected house in Oskořínek, which was in a bad technical condition (Fig. 3), the transfer to the open-air museum was the only option for its conservation.

Fig. 3 House No. 65 in Oskořínek with the "Podsň".  
September 2014

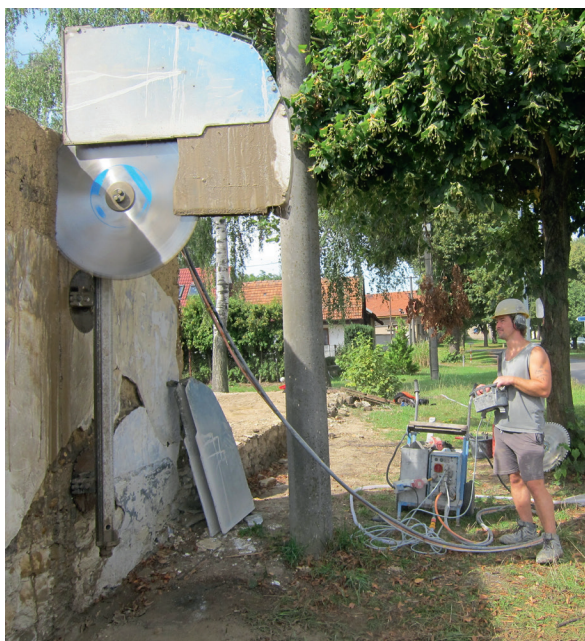
Fig. 5 Cutting of the earth wall to the store room on the street facade with a water-cooled diamond circular saw

most of them should be taken apart into individual bricks and assembled again after the transfer, following closely photographic documentation and measurements. At the same time the company drafted a method for their storage until their re-use. For the transfer in blocks, only a section of the rear part of the perimeter wall of street façade of the house remained. It was cut by a water-cooled diamond circular saw into two compact blocks weighing about 4.2 tons (Fig. 5).

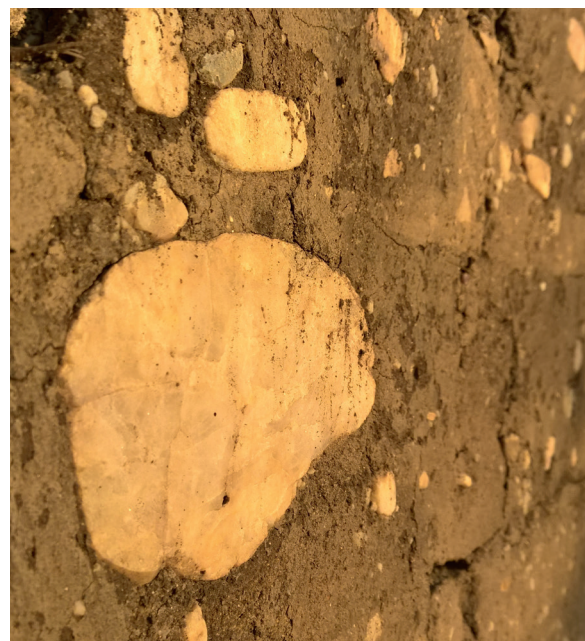
During the cutting of the wall, a very interesting material composition of the unburnt bricks with rough stone cobbles sized up to 10 cm was found (Fig. 6). The very transfer of the unburnt bricks masonry was presented by the NPÚ ÚOPSC, the realisation company, the Ethnographic Museum of Polabí Region in Přerov nad Labem and the media as the first in the Czech Republic. In the time of the action, all available information led to this conclusion. In reaction to the published news about the clay masonry transfer in Oskořínek, the chief custodian of Velhartice state castle sent to the NPÚ ÚOPSC information about a transfer of two compact walls from unburnt bricks to the castle settlement that had been realized in 2007. However, the unique action was not described in the professional literature and couldn't serve as an information source for the preparation of the Oskořínek transfer. The technology of securing of the masonry blocks and manipulation with them was completely different. The unburnt brick walls in Velhartice were

Fig. 6 The cut surface of the wall

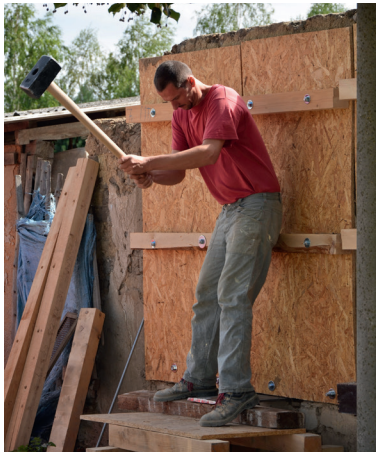
Fig. 7 Hammering in the steel plates beneath the wall

In Oskořínek, a timber frame was used constricting a shell made of thick OSBs. The realisation company drew on their own experience with the production of formwork for rammed walls. Originally suggested separation geotextiles between OSBs and blocks of masonry were not used; it was found during the formwork assembling that the OSBs were smooth enough and it was not necessary to separate them from the masonry. On the contrary, due to not using the geotextiles, the surface of the clay masonry was not damaged. The company designed suspension brackets as metal loops at the threaded rods, vertically led through bottom lengthwise beams and bearing steel plates, secured by the screw female from below. Carrying capacity of each of the four brackets of a block was 2.5 tons. That's why the main bearing part of the construction were massive crosswise steel plates, five per each masonry block (Fig. 9). The 10 mm thick plates with pre-drilled holes had one short edge sharpened and one blunt so that they could be hammered into cut underneath horizontal groove separating unburnt bricks masonry from the stone underpinning (Fig. 7). The advantage

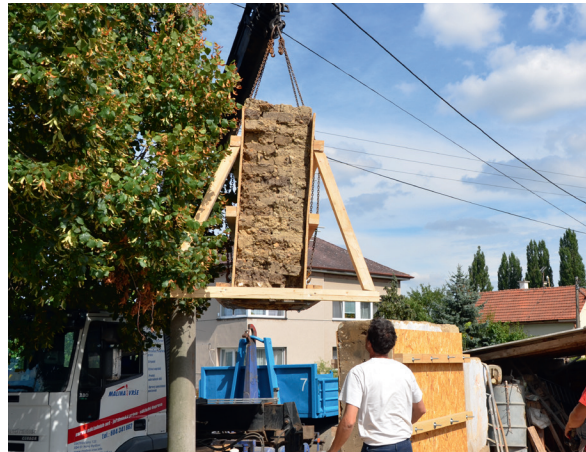
Fig. 8 Transfer of the first block with a hydraulic crane arm. Cracks are visible in the wall.

The clay blocks were transported by the hydraulic arm truck with a carrying capacity of 12 tons (Figs. 8 and 9) and were placed onto flat stone underpinning (Fig. 10). The masonry was therefore transferred without the original underpinning; in this the technology differed from the unburnt bricks masonry transfer to Niedersulz Village Museum in Austria [5]. The used transfer technology of the unburnt brick wall blocks proved very successful. The seated clay blocks fixed by the formwork could be relatively easily moved when needed. It was even possible to save part of the much damaged original plaster. After the seating, the blocks were properly bonded with brickwork from the original clay bricks. One of the blocks was successfully transferred even with an existing static crack (Fig. 8). Partly damaged margin was cautiously disassembled and prepared with careful brickwork from original bricks (Fig. 11) for connecting with adjacent perimeter walls. The saved original unburnt bricks were used for the re-construction of perimeter walls of the hall and the storage room part of the house. The opposite lengthwise perimeter wall with window segmental arches and original metal bars was successfully masoned on the clay mortar from the saved original bricks (Fig. 11).

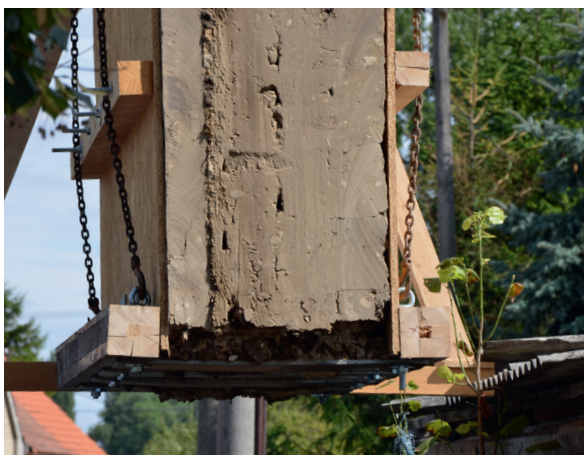
Fig. 9 Detail of the construction of the formwork, the bearing steel plates and the supporting brackets

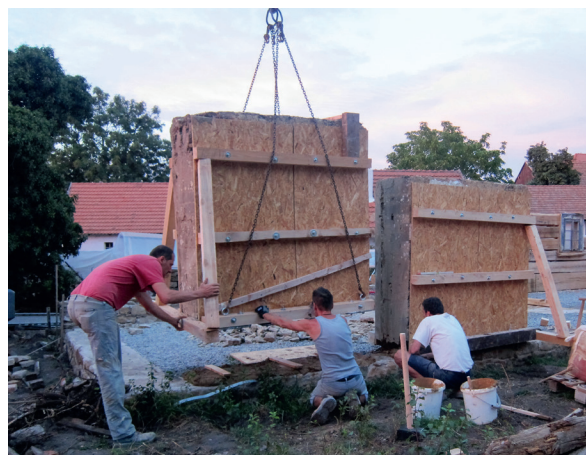
Fig. 10 In Přerov nad Labem: the wall sections are seated on a new, pre-built wall base, September 2015

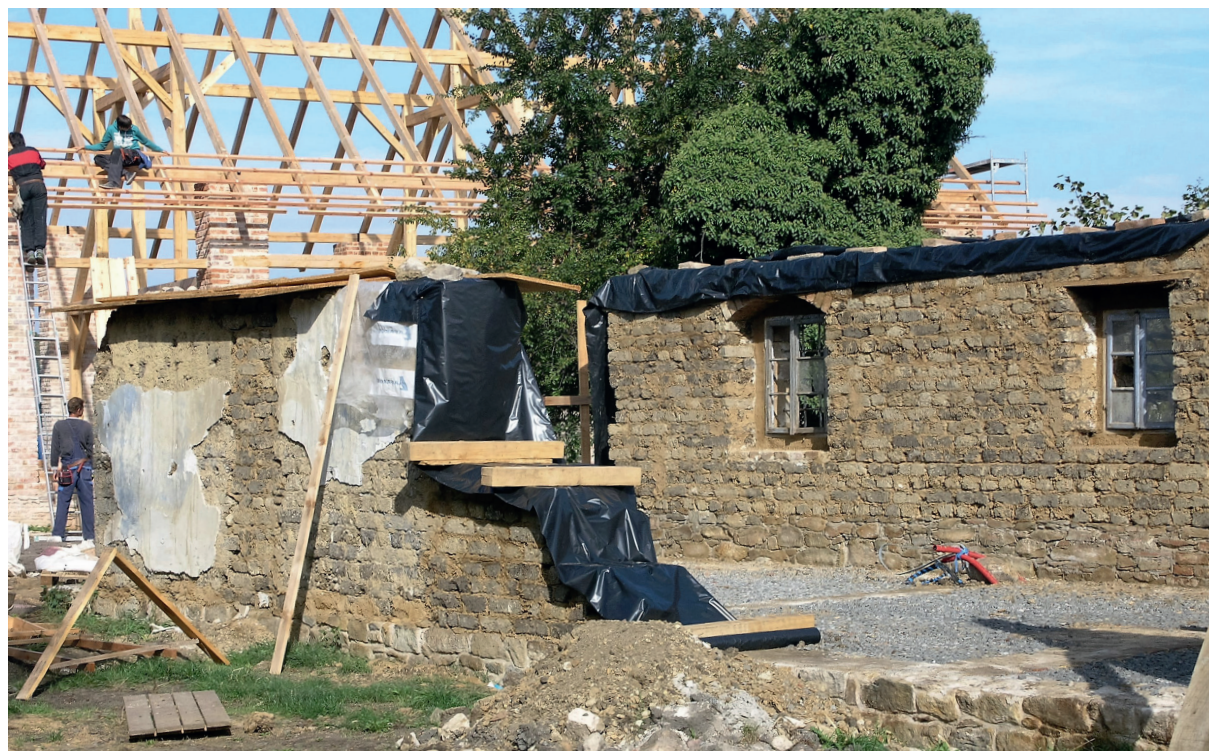
Fig. 11 In Přerov nad Labem: the two walls sections are in the foreground, the stabilised block with the cracks on the right. In the background, the newly built courtyard wall made of transferred original unfired bricks. September 2015.

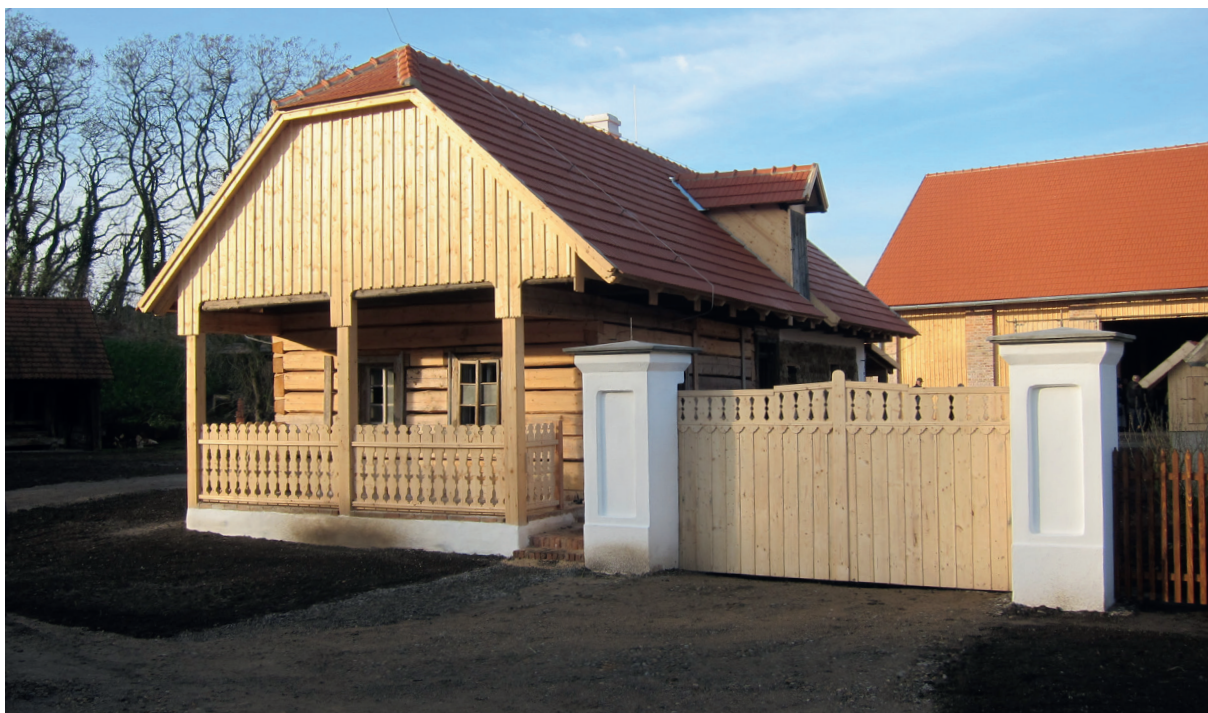
Fig. 12 Ethnographic Museum of the Polabí Region in Přerov nad Labem. House No. 65 from Oskořínek in its new location, November 2015

This year the clay and lime plasters of the brick part of the house should be finished. Clay plasters of ceilings and timbered construction will not be applied until the next year, due to technological reasons (Fig. 12).
