# Erfahrungen beim Schutz von Lehmputz auf Strohballen-Konstruktionen vor Feuchteschäden

## Building practices to protect earthen plastered straw bale walls from moisture damage

# BUILDING PRACTICES TO PROTECT EARTHEN PLASTERED STRAW BALE WALLS FROM MOISTURE DAMAGE

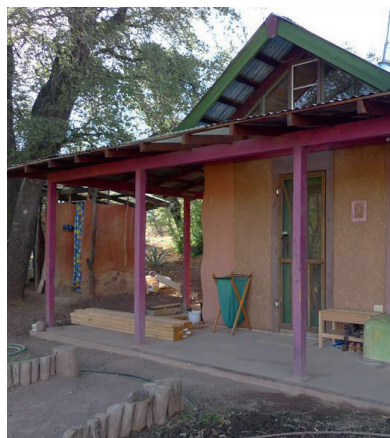
2 Typische Bereiche hoher Feuchtigkeit in den inneren Wandbereichen im Sommer und Winter  
2 Typical areas of high interstitial moisture in summer and winter

In summer, interstitial relative humidity tended to increase towards the lower portion of the wall. In winter the trend reversed with interstitial relative humidity increasing towards the upper portion of the wall (Fig. 2.).

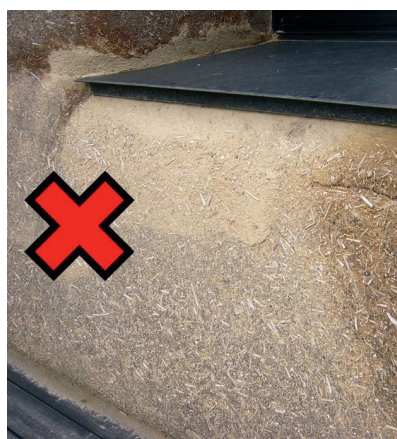
6 Ausreichende Sockelmauern und richtige Umfeldgestaltung schützen die Wände vor Spritzwasser  
6 Sufficient stem walls and proper landscaping protect walls from splash back

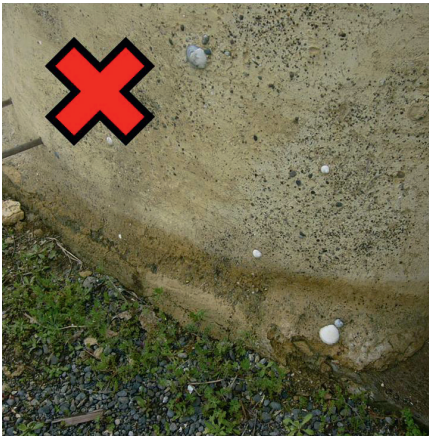
9 Erhöhe die Austrocknung durch Sicherung einer guten Belüftung um die Außenwände  
9 Increase drying by ensuring good ventilation around exterior walls

7. Ensure good ventilation around exterior walls, free of vegetation, to increase drying (Fig. 9.).
8. Grade around a building so that surface water runs away from the building. In cases where this is not possible, use drains and swales to intercept surface and ground water. Create a network of perforated drainage pipe sloped to daylight to carry ground moisture away from buildings. Depending upon conditions, perforated drainage pipe can be installed under roof lines and next to foundations and footings.

7. Sicherstellen einer guten Ventilation um die Außenwände, frei von Bewuchs, um das Abtrocknen (nasser Wände) zu beschleunigen (Fig. 9.).
8. Ein ebenes Gelände um das Gebäude sicherstellen, damit das Oberflächenwasser vom Gebäude weglaufen kann. Dort wo das nicht möglich ist sollten Rohre und Mulden genutzt werden, um das Oberflächen- und Grundwasser abzufangen. Anlegen eines Netzes durchlässiger Drainagerohre vom Gebäude weg, um Grundwasser vom Gebäude wegzuleiten. Abhängig von den konkreten Bedingungen können diese Rohre unter Dachkanten und an Fundamenten und Fußpunkten angelegt werden.

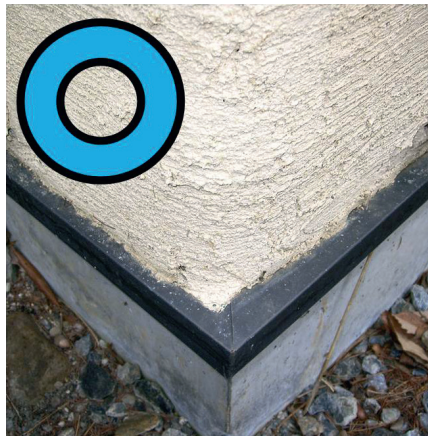
10 Dampfsperre über dem Fundament  
10 Damp-proof course above foundation

9. Separate bale walls from foundations with a damp proof course (Fig. 10.).
10. Separate exterior plasters from foundations and ground moisture with a capillary break, such as metal flashing (Fig. 11.).

9. Abtrennung der Strohballenwände zu den Fundamenten mit einer Feuchtigkeitssperre (Fig. 10.).
10. Abtrennung der Außenputzschicht von den Fundamenten und der Bodenfeuchtigkeit durch eine kapillARBrechende Schicht, z.B. Metallblech (Fig. 11.).
