## Verstärkung beschädigter Gebäude aus stabilisierten Lehmsteinen

## Retrofitting of damaged stabilised earth block buildings

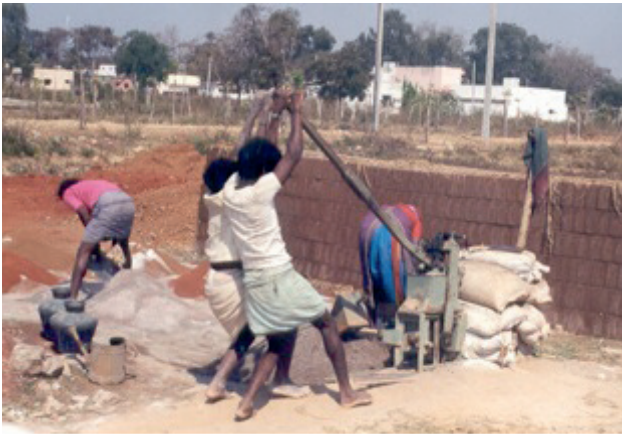
1 SMB Herstellung (Handpresse)  
SMB production (manual press)

Lehm kann sowohl durch den Verdichtungsprozess als auch durch die Verwendung von Zusätzen wie Zement, Kalk usw. stabilisiert werden. Die SMB-Herstellung nutzt beide Prozesse. Die wesentlichen Schritte bei der SMB-Produktion sind: (a) Auswahl von geeignetem Lehm und Zugabe von Sand, um ein optimales Mischungsverhältnis zu erreichen, (b) Herstellung des Lehm-Sand-Gemisches, Mischen der erforderlichen Menge des ausgewählten Stabilisators und Zugabe der richtigen Wassermenge sowie (c) Pressen des Blocks in der Maschine zur benötigten Verdichtung (Abb. 1) und Trocknung.

of the earth by adding sand to obtain an optimum mix composition, (b) processing earth-sand mixture, mixing of adequate quantity of selected stabilizer and addition of optimum water and (c) pressing the block in a machine to the required density (Fig. 1) and curing.

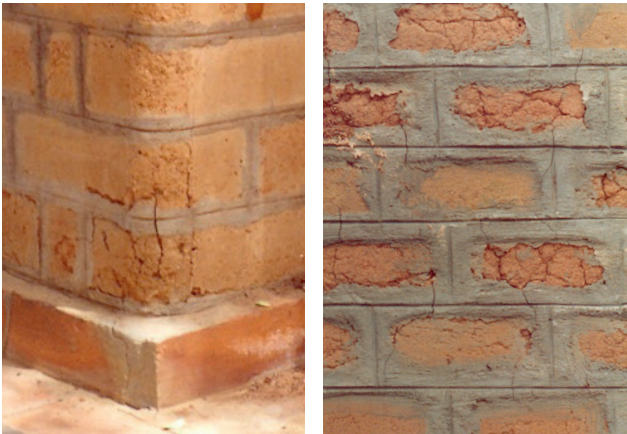
2 Spannungsrisse durch Schwinden  
Splitting cracks due to shrinkage

Among the several factors pertaining to material composition, the clay minerals present in the block are a major contributing factor for the long-term deterioration of SMB. Unstabilised clay pockets possess lot of affinity for water. On absorbing water clay can undergo swelling, on drying shrinkage. This is manifested as surface cracks as shown in Fig. 2. Cyclic wetting and drying can disrupt the established cementitious bonds between various particles causing SMB to deteriorate with age. Frost action can also cause established cementitious bonds among various particles within the SMB matrix to snap leading to the deteriora-

Performance of the SMB masonry wall greatly depends upon the quality of the SMB. The distress and damage in exposed SMB walls can be broadly classified into the following three types of damages: (a) the splitting of surface cracks (Fig. 2) (b) erosion and pitting (Fig. 3) and (c) cracking and spalling (Fig. 4 and 5). All three types of damages can be attributed to the inadequate stabilisation of the clay mineral in the earth used for SMB. Three types of repair and retrofitting techniques are possible depending upon the extent of damage the exposed SMB wall has suffered. Details of these three types of repair and retrofitting are discussed below.

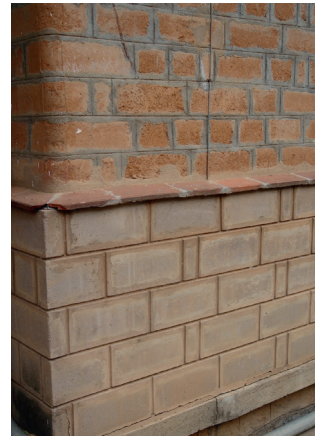
Damages to SMB walls caused by any of the processes explained in the previous section can be very severe. Such damages can jeopardise the safety of the building and could lead to collapse. Fig. 12 shows one such situation. A collapsed wall (either partially or fully) can be rebuilt without disturbing the neighbouring areas or sections of the wall above. The procedure followed and precautions to be observed in such repair/retrofitting works are highlighted below:

Schäden an SMB-Wänden, wie oben dargestellt, können sehr schwerwiegend sein. Ernsthafte Schädigungen der Wände können die Sicherheit des Gebäudes gefährden und zu dessen Versagen führen. Abb. 12 zeigt ein solches Versagen. Die eingestürzte

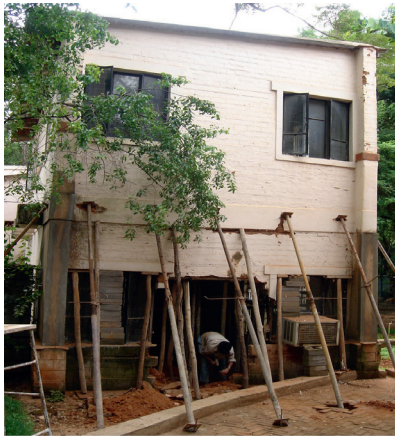
- 1 Support the floor or roof slab with properly designed props so that the wall to be repaired is temporarily relieved of its load.
- 2 Divide the wall into a number of sections approximately 1.0 m wide. Remove one section of the wall and rebuild the portion with good quality SMB blocks.
- 3 Ensure that the brick coursing at the edges of each section is such that it interlocks with the next section.
- 4 The SMB wall is rebuilt progressively in one metre sections and cured for a week. Fig. 12 illustrates an example of such a retrofitted SMB wall.
- 5 Allow the wall to dry for 2-3 weeks before applying load to the wall by releasing the temporary props supporting the floor or roof slab.
- 6 Fig. 13 shows a retrofitted SMB wall that does not affect the first floor wall.

- 1 Abstützen der Decke oder des Daches mit Stützen, die geeignet sind, die Last auf die Wand zwischenzeitlich aufzunehmen.
- 2 Unterteilen der Wand in eine Zahl von Abschnitten von etwa 1,0 m Breite. Entfernen eines Abschnittes und Erneuern der Wand mit qualitativ hochwertigen SMBs.
- 3 Verzahnung der einzelnen SMBs zwischen den Abschnitten gewährleisten, damit eine gute Verbindung untereinander im Mauerwerk erreicht wird. Die SMB-Wand wird schrittweise in Abschnitten von 1,0 m erneuert und eine Woche nachbehandelt. Abb. 12 illustriert ein solches Beispiel von verstärkter SMB-Wand.
- 4 Die Wand sollte 2-3 Wochen trocknen können, bevor sie wieder belastet wird, indem die zwischenzeitlich eingesetzten Stützen wieder entfernt werden.
- 5 Abb. 13 zeigt eine erneuerte SMB-Wand,- bei der das Obergeschoß unbeeinträchtigt blieb.

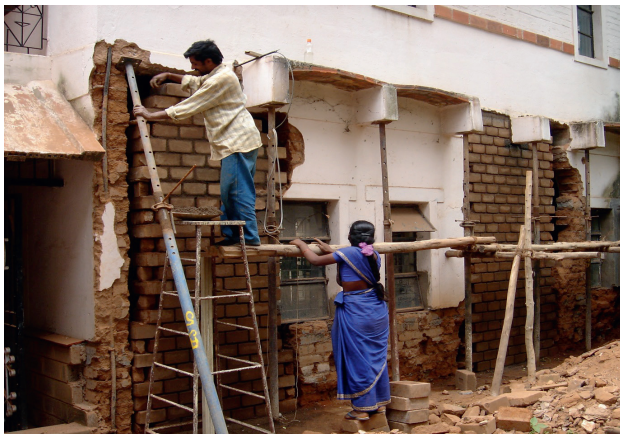
12 Einsturz des Endes einer Wand und Erneuerung mit qualitativ hochwertigen SMB  
Collapse of an end wall and retrofitting with good quality SMB wall

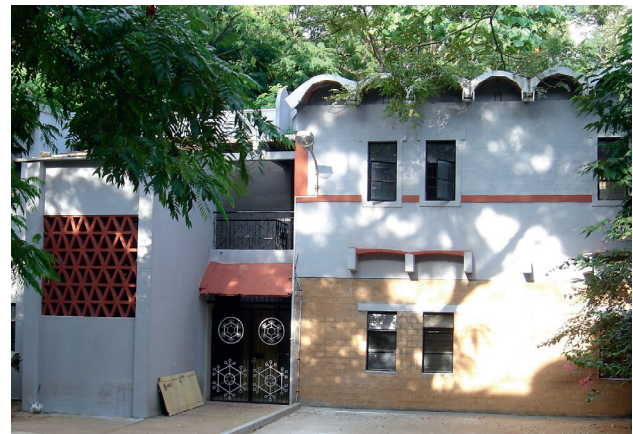
13 SMB-Gebäude nach Erneuerung  
SMB-Building after retrofitting
