Der UTS Dauerhaftigkeits-Test für Lehm-Wand-Konstruktionen

The UTS Durability Test for Earth Wall Construction

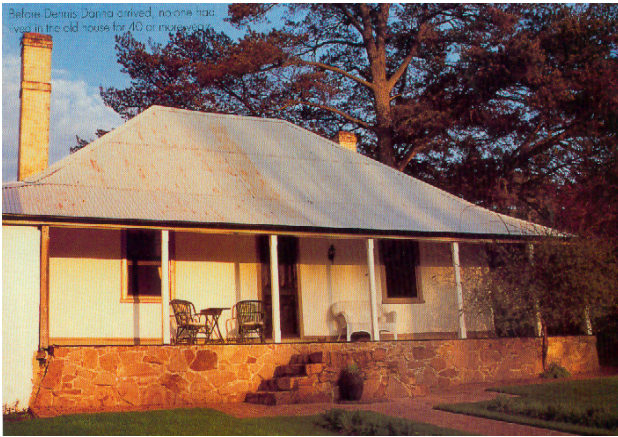
1 Pisé Haus bei Bathurst 1850 (beachten Sie den weiten Dachüberstand und die verputzten Wände)
Pisé house near Bathurst 1850 (note the wide roof overhang and rendered walls)

In Australia Governor Philip began a new settlement at Parramatta and before the end of 1790 there were thirty-two houses completed, built of wattles, plastered with clay and thatched (Archer, J, 1987), Termites, rain and increasing property development led to the destruction of all early earth wall buildings in Sydney. The earliest remaining earth buildings are from the mid nineteenth century and are all located in rural areas far from the city. It should be noted that these remaining buildings have well maintained surface coatings as well as wide roof overhangs (Fig. 1)

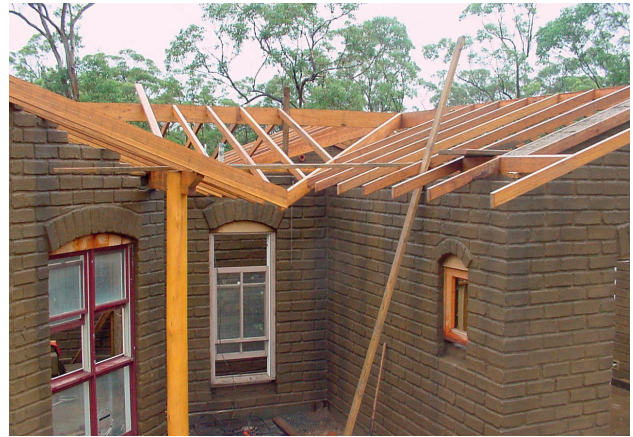
2 Moderne Australische Lehmwandkonstruktion
Modern Australian Earth Wall House

With the advent of the industrial revolution earth wall construction declined during the mid nineteenth to mid twentieth century, however shortages of building materials following the Second World War led to a renewed interest in earth wall construction. The preferred wall construction material in Australia is fired clay brick without an external coating and this same appearance is preferred in earth wall construction (Fig. 2).

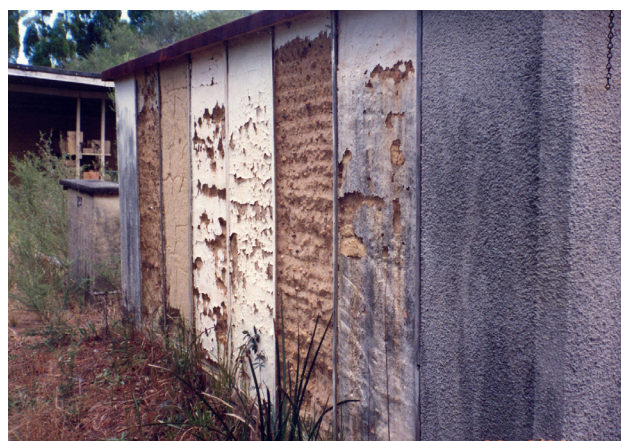
4 Lehmwände nach 43 Jahren
 Earth Walls after 43 years

For effective prediction of the service life of earth buildings it is necessary to have an accelerated durability test which is a reliable predictor of in-service performance. Middleton (1952) constructed many rammed earth test walls at the Commonwealth Experimental Building Station in Sydney in 1949. What these experiments demonstrated, after 43 years of exposure, was the dramatic effect climatic conditions have on the durability of earth walls (Fig. 4).

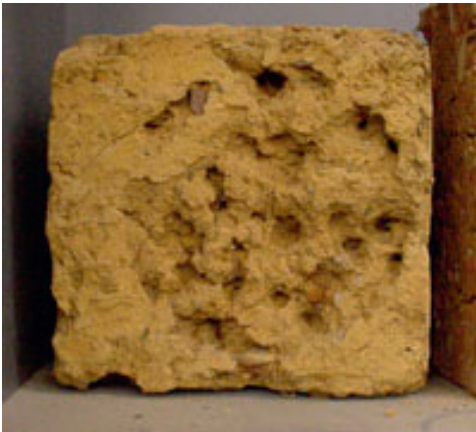
7 Lehm-Block mit Erosion in Folge von Bulletin 5-Test
Earth Block showing erosion created by Bulletin 5 Test

Two general difficulties in using the Bulletin 5 test to predict earth wall performance became obvious to the authors. The first is that the test does not in any way simulate rainfall and as can be seen in Fig. 7 actually bores holes in the specimens. Secondly in interpreting the results of the test no consideration is given to the climatic conditions in which a proposed building is to be located.

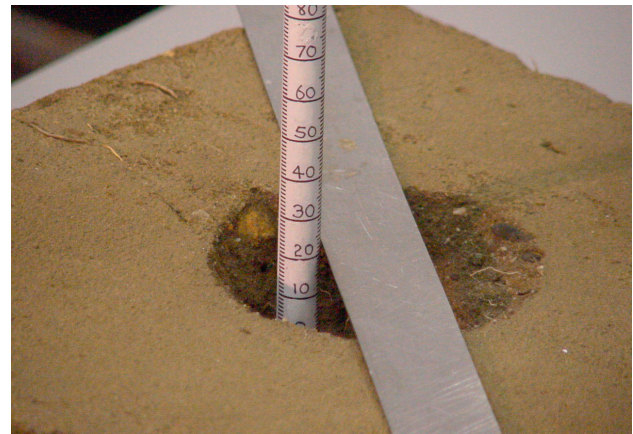
12 Messung der Maximalen Tiefe der Erosion mit einem 10mm Skalierstab, UTS-Test
Measuring Maximum Depth of Erosion with 10mm Graduated Rod - UTS Test

Specimens are then sprayed for the calculated duration and the resulting erosion depth measured (Fig. 12).
