Restoration der Zitadelle von Bam – neue Herangehensweisen

The Restoration of Bam Citadel, Iran – new approaches

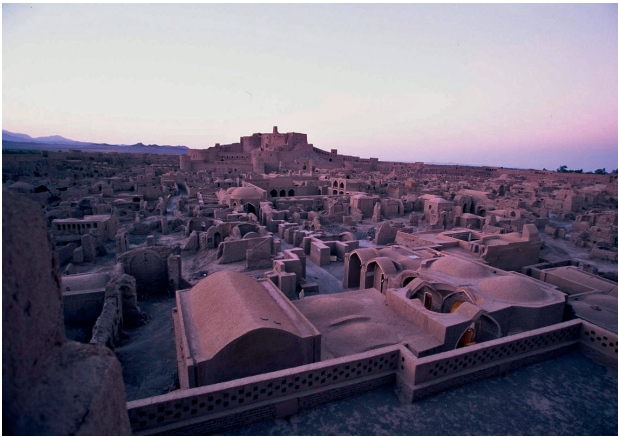
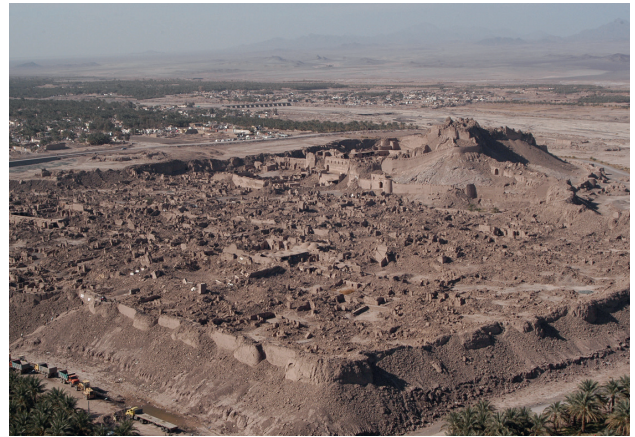
In the early morning of December 26th 2003 a strong earthquake shook the ancient City of Bam and caused heavy destruction in the city and the beautiful Bam Citadel. This tragic event caused the loss of many lives and destabilized and seriously damaged the earthen structures within the Bam Cultural Landscape (Fig. 1).

1a & 1b Die Bam Zitadelle vor und nach dem Erdbeben. Bam Citadel, before and after earthquake.

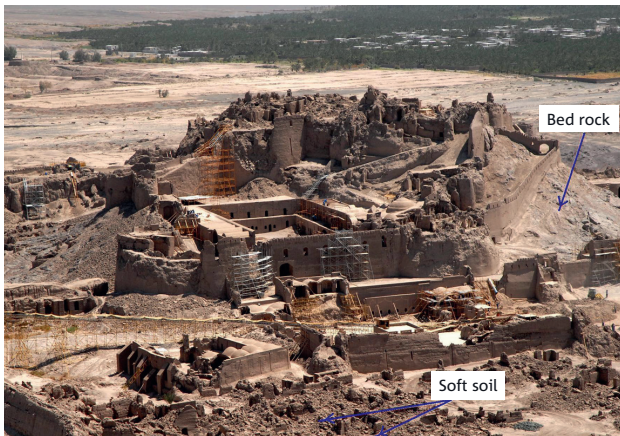
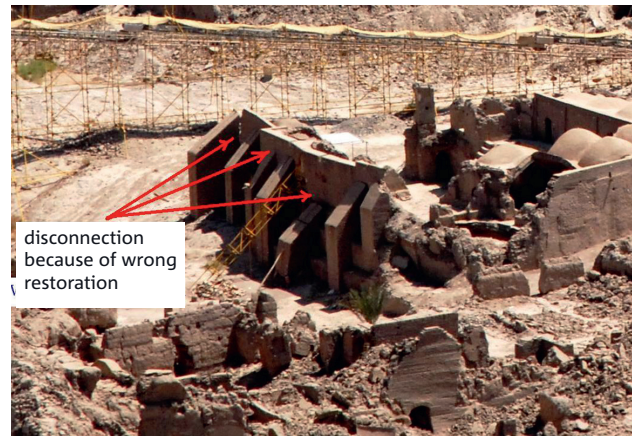
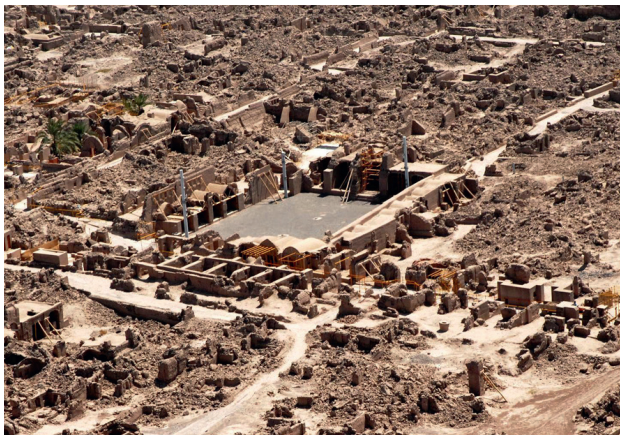
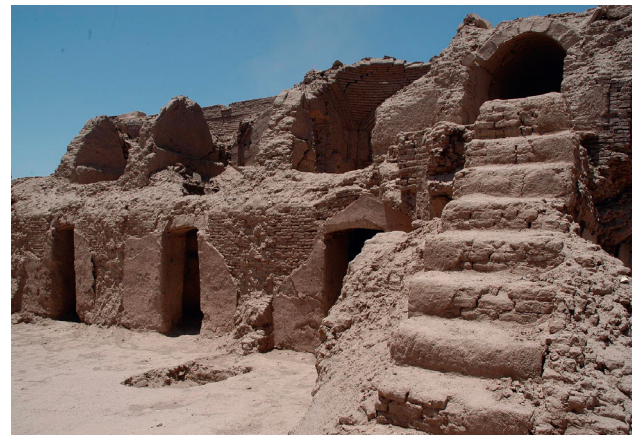
2 Karte mit der prozentuellen Auflistung der Schäden. Map showing the percentage of demolition.

3 Die zusammengebrochenen Säulen in der Jaame Moschee. General collapse of the columns in Jaame Mosque.

4 Der Felsenuntergrund im Gouverneursdistrikt hat dynamisch anders reagiert, als der unter der Jaame Moschee. / The bed rock in District of Governor caused a different dynamic response compared with Jaame Mosque.

7 Zerfall und Schwächung der Adobekonstruktion in alten Bauteilen. Decay and weakness of adobe as an old construction material.

- Schäden, die durch die Dynamik des Erdbebens hervorgerufen wurden: Es besteht eine Beziehung zwischen der Erdbebendynamik und derjenigen in einer Gebäudestruktur (Abb. 3 und 4).

- Damage caused by dynamic earthquake loads; this kind of damage is dependent on the relationship between the dynamic aspects of earthquake loads and the dynamic aspects of a structure in the same fundamental period. For example the damage that occurred to Jaame Mosque (Fig. 3) and the different dynamic response in the District of the Governor (Fig. 4).

provide a better response and avoid much of the damage that is likely occur during an earthquake (Fig. 7).

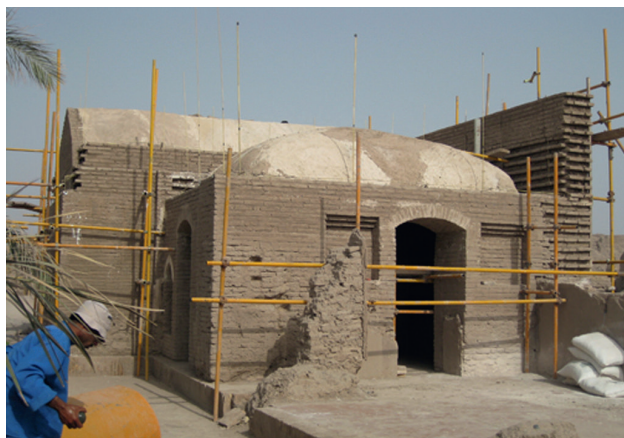
5 Falsche Einbindung der Strebepfeiler in die Westwand der Karawanserei. Incorrect intervention: the buttress behind the west wall of the Caravanserai.

- Vorherige Eingriffe: Vorangegangene Renovierungsmaßnahmen bezogen sich mehr auf architektonische Details als auf die strukturelle Sicherheit der Bauten bei Erdbeben. Das zeigt sich z. B. bei der Trennung der Wände von den Strebepeilern in der Karawanserei (Abb. 5).

- Previous interventions: Previous measures have been more focused on the architectural form and area than on the response of the structure to the earthquake. For example, the separation of the walls and buttresses in the west part of Caravanserai (Fig. 5) could be considered.

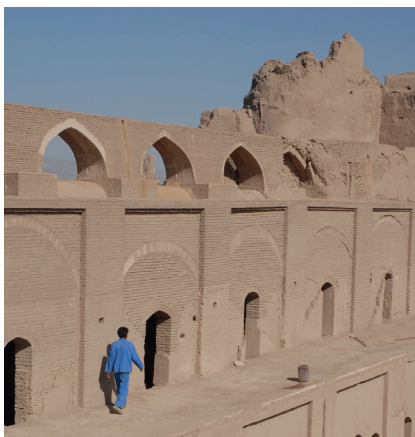
6 Die Integrität des Gebäudeträgerwerks bietet von sich aus genügend Widerstand gegen Erdbeben. / The integrity of the structure could provide sufficient resistance against earthquake loads.

- Entwurfsfehler: Durch die lange Periode zwischen dem vorletzten und letzten Beben wurden keine Erdbebeneinflüsse auf Lehmbauten untersucht. Es gab ja auch in der Vergangenheit keine Möglichkeiten unter Laborbedingungen Erdbeben zu simulieren. So unterblieb eine Analyse von Baufehlern. Heute sind die strukturellen Voraussetzungen für erdbebensicheres Bauen bekannt (Abb. 6).

- Incorrect design: With regard to the long repeat cycle of earthquakes in the Bam area and the lack of the instruments in the past, it was impossible to analyze the structural behavior in the event of an earthquake or to simulate the effect of an earthquake on the structures in the laboratory. The integrity of historical buildings, the valid forms of construction and the absence of connection between the load-bearing parts play a substantial role in reducing the degree of collapse in an earthquake (Fig. 6).

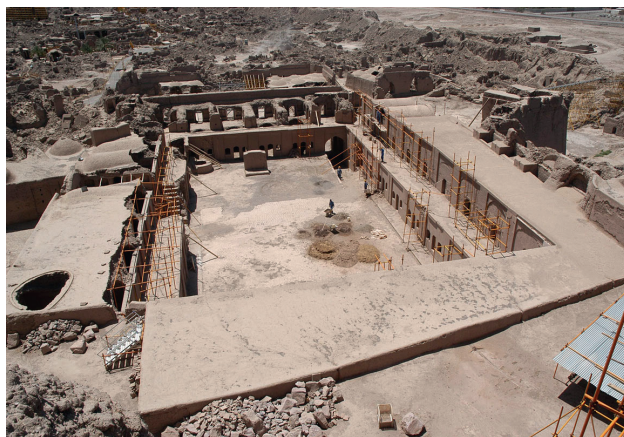
- Schwaches Material: Lehmsteine sind nicht stark genug gegen Belastung durch Erdbeben und/oder Wind (Abb. 7). Es müssen Steine mit besonderer Ausführung und spezifischen Formaten hergestellt werden. Die Kuppeln der Ställe im Nord-

- Weak material: Adobe masonry is inherently weak against the lateral loads such as earthquake and wind. Another time the use of bricks with higher resistance specification would

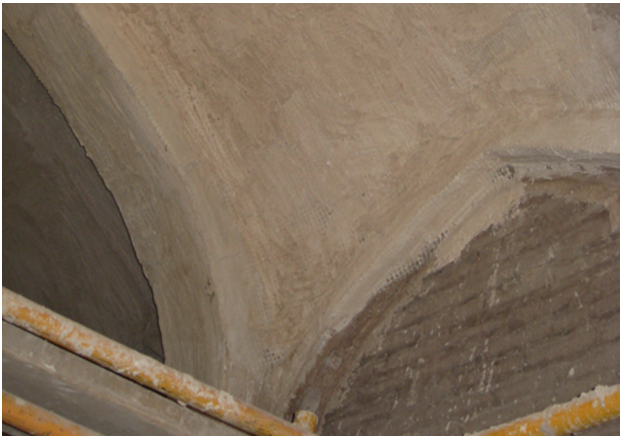
- Keine Fundamente: Die meisten Gebäude der Zitadelle wurden ohne Fundamente gebaut. Die ersten Lagen von Adobesteinen der Wände wurden direkt auf dem Boden aufgebracht und waren so ohne weiteren Halt den Elementen usw. ausgesetzt. Die Windgeschwindigkeit erreicht in Bam manchmal 130 km/h, was größere Auswirkungen hat auf Lehmbauten als andere Elemente oder Einflüsse (Abb. 8).

8 Von Termiten geschädigter Palmstamm, der in der Wand vom Kühlhaus als Zuelement verwendet wurde. / Termite effect, the decayed palm tree in the wall of Ice House (acting as a tensile element).

- The structure and some specific conditions: Form and shape can definitely have an effect on the seismic response of structures. The domes of the Stable in the north-east have worked well without damage, however the wall has collapsed. The north wall acts as a support for the structures beneath.
- Most of the building in Bam Citadel had been built without foundations. This means that the first layer of the adobes rested on the ground and formed the ground course. This weakness should have been eliminated by incorporating elements to resist vertical uplift.
- Natural factors, such as wind, termites, etc.: The wind speed in Bam sometimes reaches around 130 km/h, which intensifies the decay or is major natural factor. There are some places in the Citadel which show serious biological corrosion (Fig. 8).

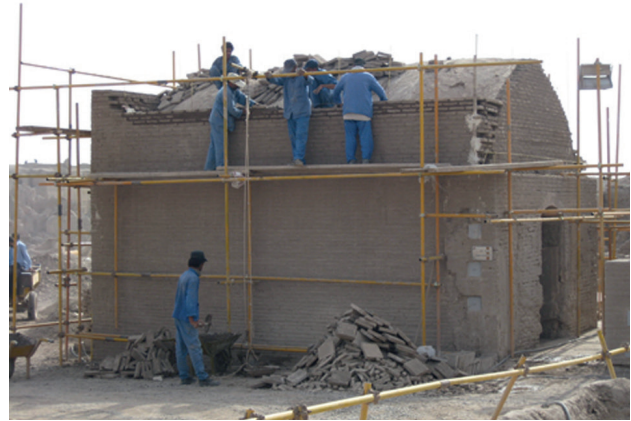
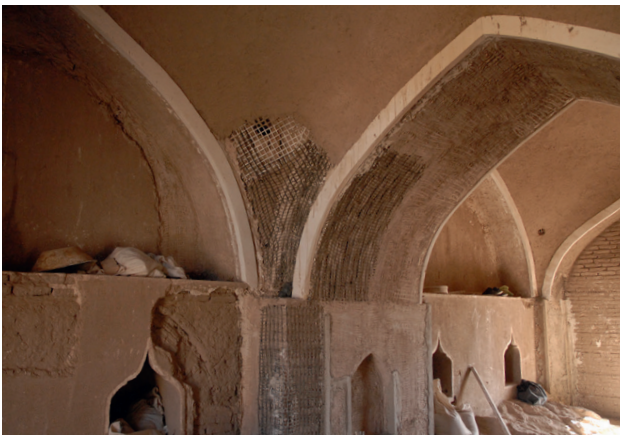
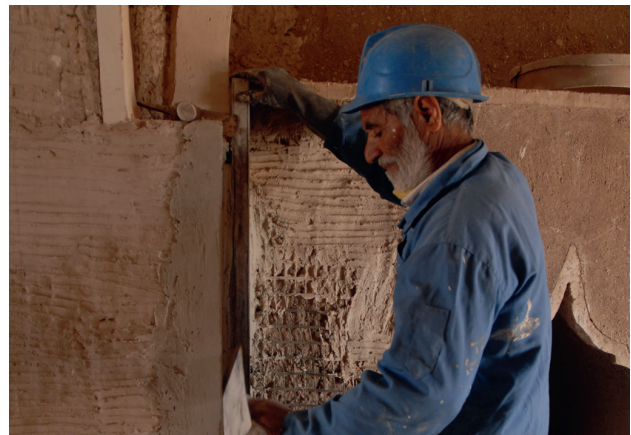
In traditioneller Art und Weise (Abb. 9):

Unbewehrtes Mauerwerk überträgt Lasten direkt in das Fundament oder in die Fundamentwände. Bewehrtes Mauerwerk wird mit natürlichem Material wie Stroh (in Adobe) oder Holz- und Palmenabfall zur Verbesserung der Zugeigenschaften verstärkt.

9 Untere Reihe: Traditionelle Sanierungsmethoden in der Bam Zitadelle mit RPBCB. Bottom row: Traditional method for restoration of the Barracks, Bam Citadel (by RPBCB).

Traditional Methods (Fig. 9):

Unreinforced masonry transfers common gravity loads and infrequent environmental loads, which usually contain a major lateral component, to the foundations and associated ground blocks. Reinforced masonry can be strengthened with a natural

material like straw (in the adobe unit), wood and palm (as tensile elements), etc.
