In situ characterization of external ancient renderings of rammed earth constructions in the Algarve and of potential replacement commercial pre-mixed renderings

Scope and objectives

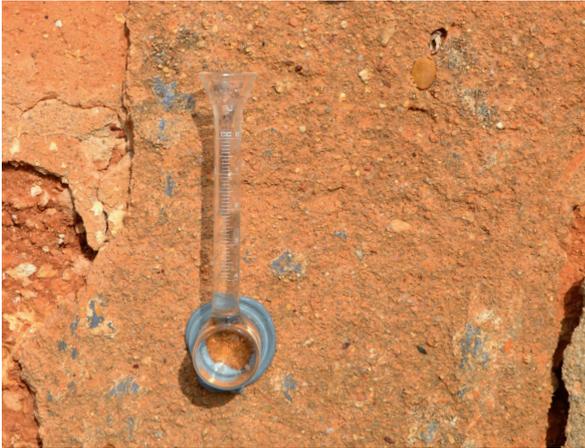
Figure 1 Water absorption using Karsten tubes, in ancient rendering.

minute in the first 5 minutes, and every 5 minutes for an hour period (Fig. 1 and Fig. 2). The same test was carried out in the ancient rammed earth substrates in order to compare the absorption rates with the corresponding rendering ones. To evaluate the mechanical capacity of the renderings, mechanical strength tests were carried out using the Schmidt pendulum hammer model PM (Fig. 3). These tests were carried out according to RILEM TC 127 MS procedures, using the pendulum hammer model PM, more suitable for the low level of mechanical strength of these renderings. This non-intrusive method measures the rendering surface hardness. The output is the rebound of the pendulum mass, measured using the equipment degree scale. Since these pre-mixed renderings are available in the market, compression strength reference values provided by the rendering manufacturers can be taken to evaluate the reliability of this test. Twenty tests were performed per pre-mixed rendering, in a total of 100 tests. Twenty tests were also performed in each of the ancient renderings. The

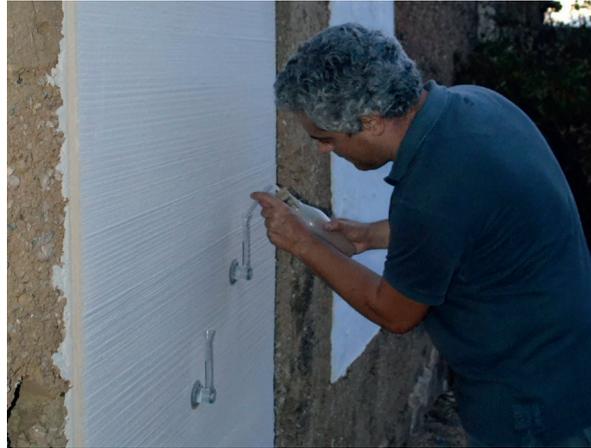
Figure 2 Water absorption using Karsten tubes, in pre-mixed commercial rendering.

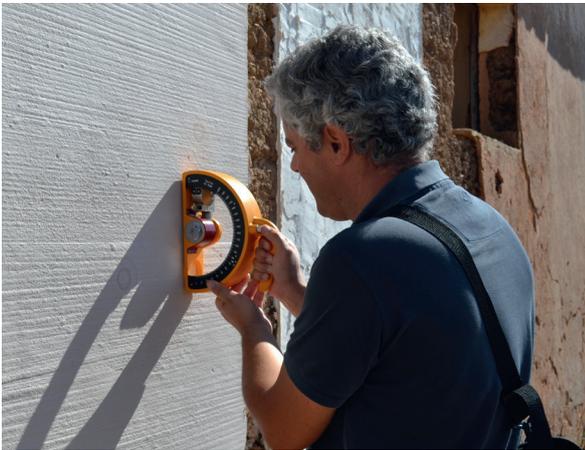
Figure 3 Mechanical strength test using the Schmidt pendulum hammer, in pre-mixed commercial rendering.

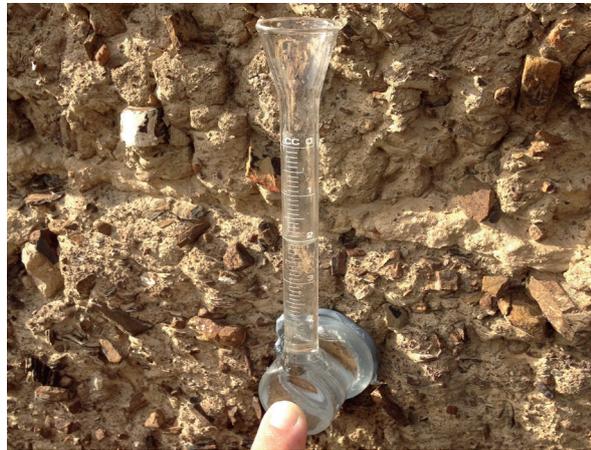
Figure 4 Water absorption using Karsten tubes, in ancient rammed earth substrate.

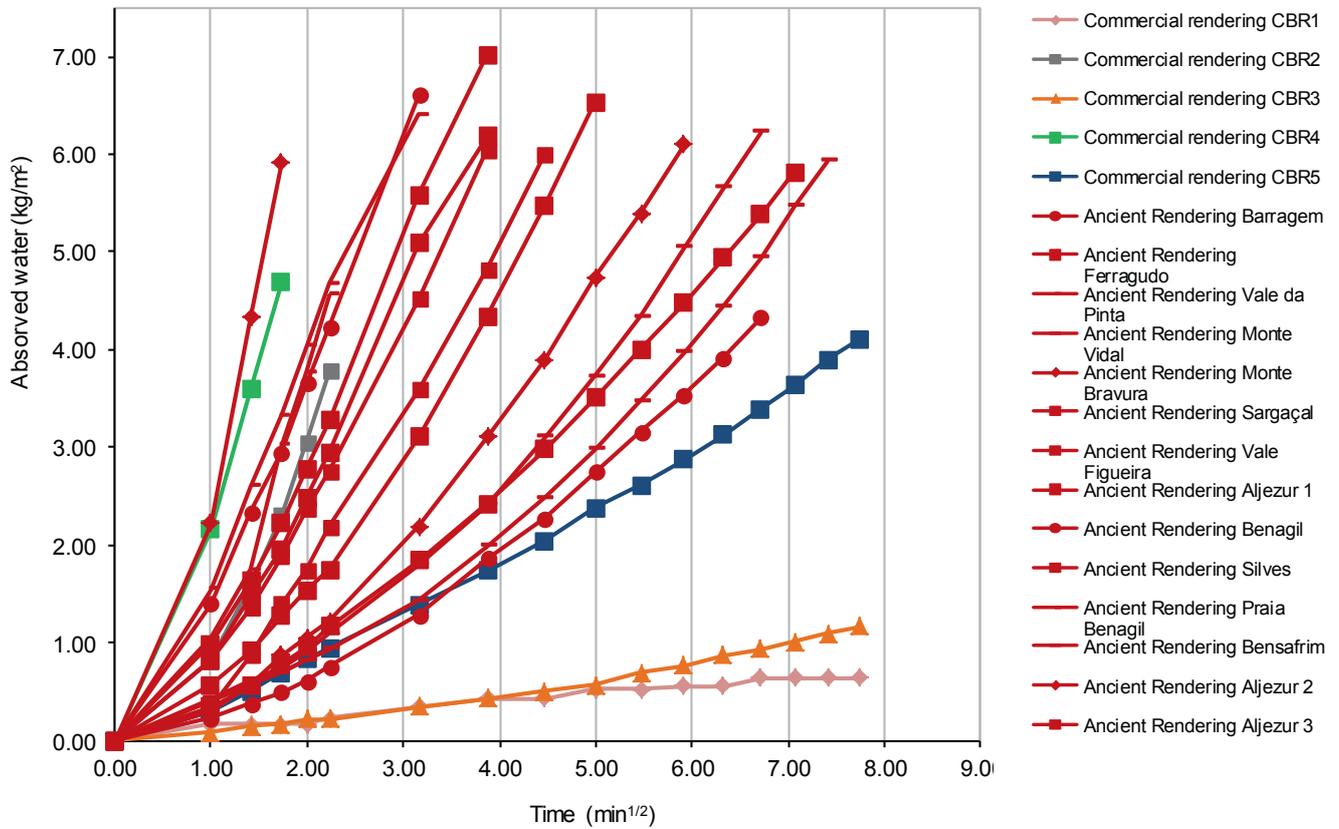
Figure 5 Water absorption of commercial renderings versus ancient renderings – in situ test (Karsten tubes)

The air lime-based ancient renderings show higher absorption rates than most of the new pre-mixed commercial renderings. The absorption lines of those ancient renderings are marked in red in Fig 5 below. The water absorption rates of new commercial renderings have a wide range of values. Three of the pre-mixed renderings have lower absorption rates than the ancient renderings and two others have higher absorption rates than most of the ancient renderings – CBR 2, which is air lime-based (grey line in Fig 5); and CBR4, which is an hydraulic lime-based rendering exclusively with cork aggregates. The cork aggregates are responsible for its high water absorption

rate (green line in Fig. 5). The ancient substrates have a wider range of water absorption rates (Fig. 8): five of them have similar rates than their renderings; two of them have higher water absorption rates than their renderings. Six of them have lower water absorption rates than the corresponding renderings implying a water retention period in the interface between the coating and the rammed earth substrate, and the contact of infiltrated water with the rammed earth substrates. Pre-mixed renderings CBR1, CBR3 and CBR5 have similar levels of mechanical strength. It was not possible to perform this test in the CBR4 rendering because of its very low strength (Fig. 7). Most of these pre-mixed renderings have similar surface hardness; exception is made for CBR2, a pre-mixed air-lime based rendering, which has a higher surface hardness value, related to its higher stiffness; CBR1, CBR3 and CBR5 have synthetic fibers in their composition that reduce their surface hardness. In spite of that, these three commercial renderings have higher compressive strength than the common traditional air-lime based renderings (Magalhães et. al 2009). This data is provided in Fig 8.

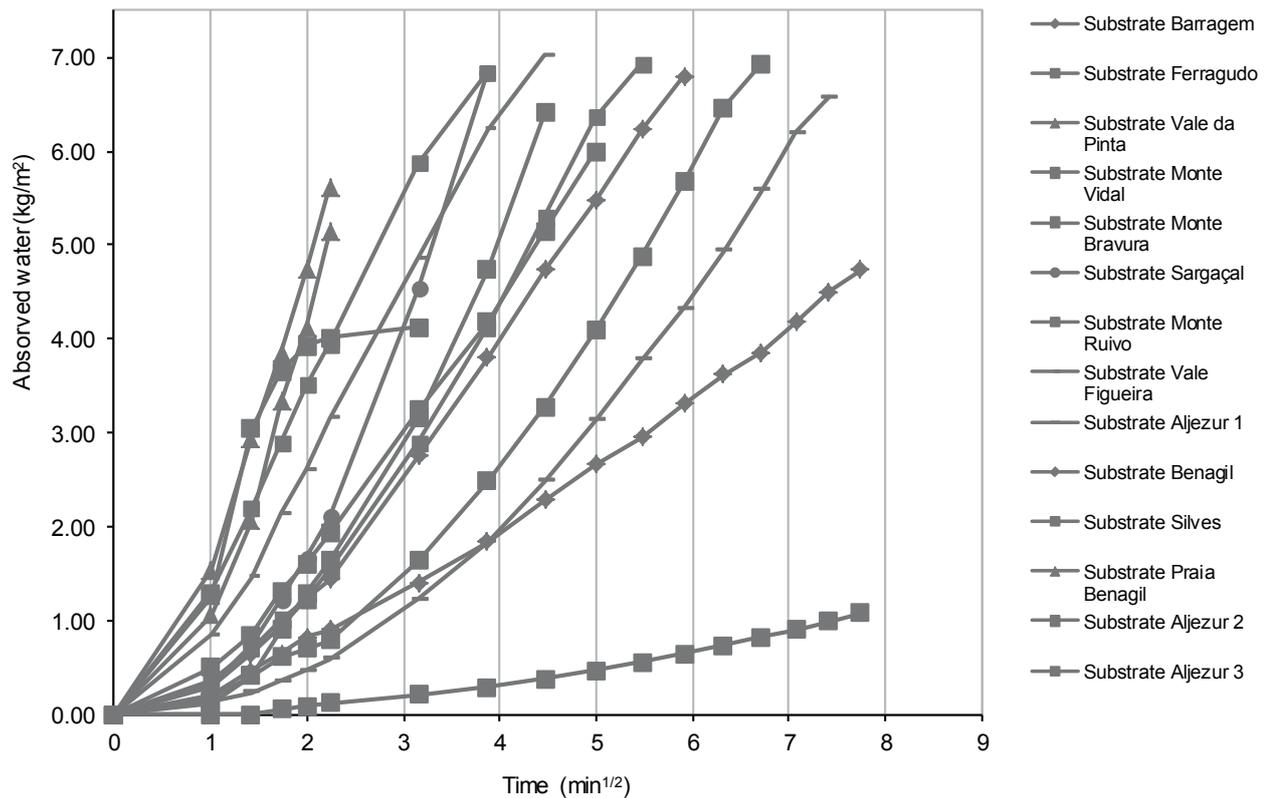
Figure 6 Water absorption of ancient rammed earth substrates—in situ test (Karsten tubes)

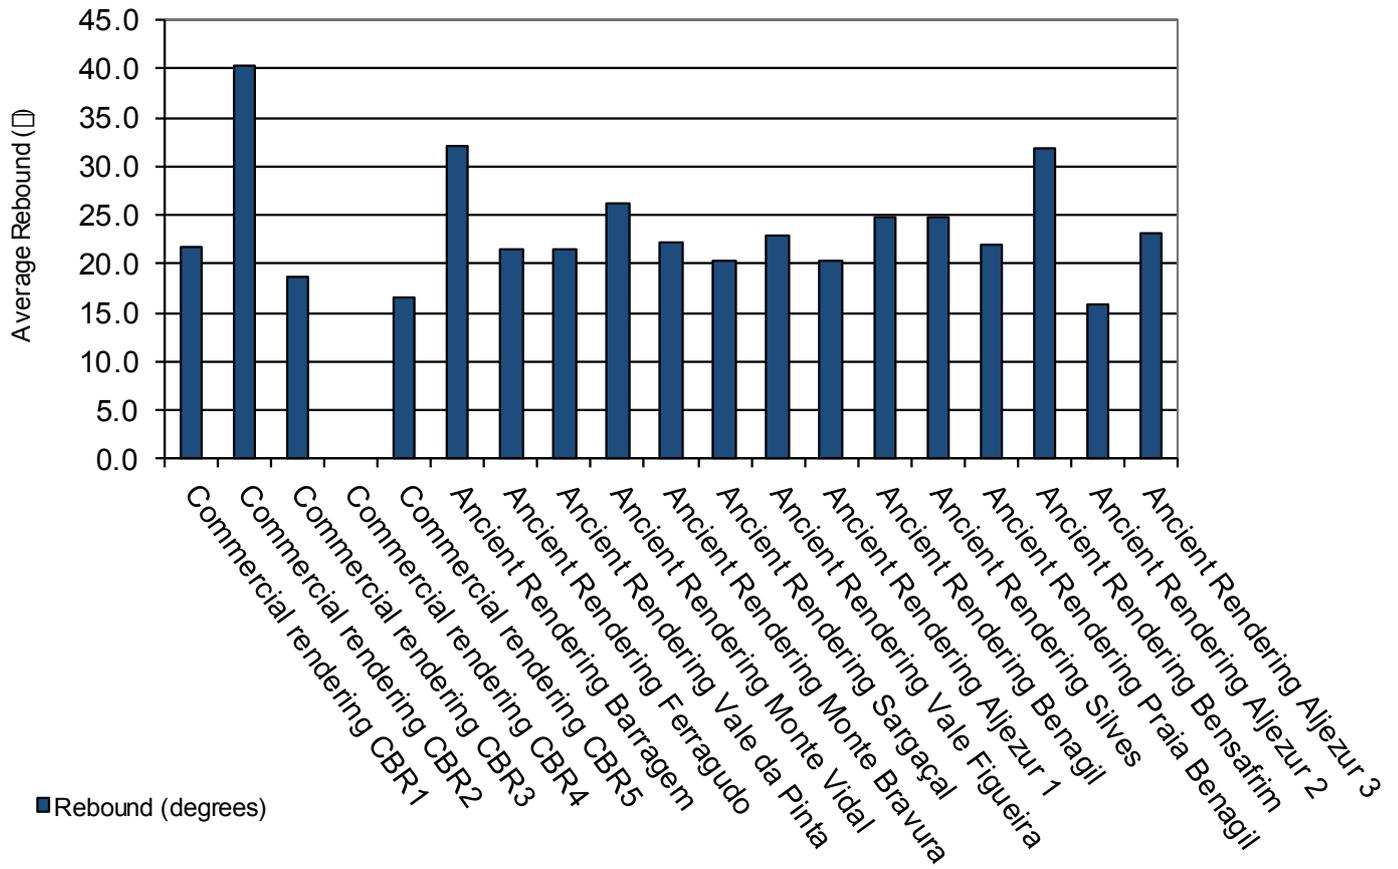
Figure 7 Superficial hardness of commercial versus ancient renderings—in situ test (pendulum hammer)

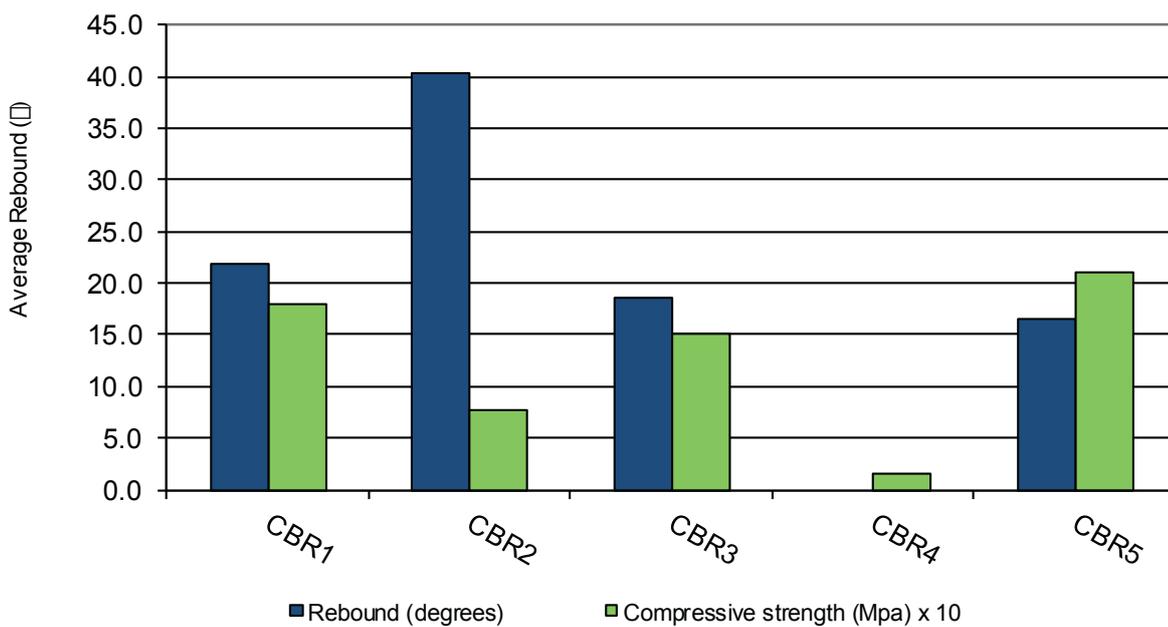
Figure 8 Superficial hardness versus compressive strength of commercial renderings
