## Die Überschwemmung von Sandema im September 2007 – Auswirkungen auf Lehmbauten

## The Sandema floods in September 2007 – its effects on earth buildings and ways forward

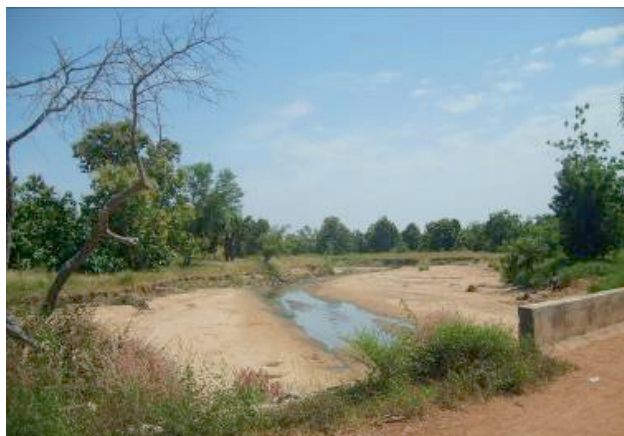
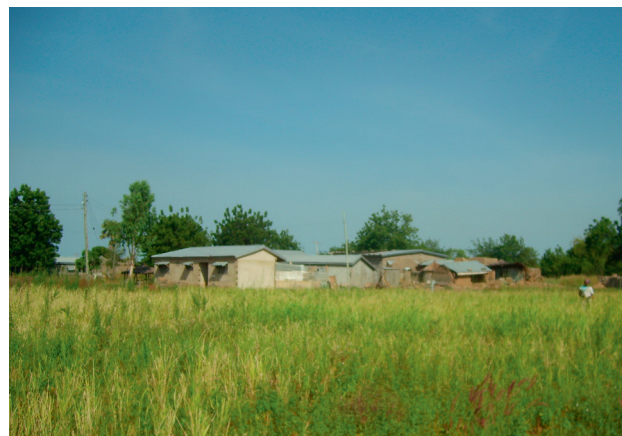
1 Lage des Builsa Distrikts in der Oberen Ostregion von Ghana  
Location of the Builsa District of the Upper East Region of Ghana

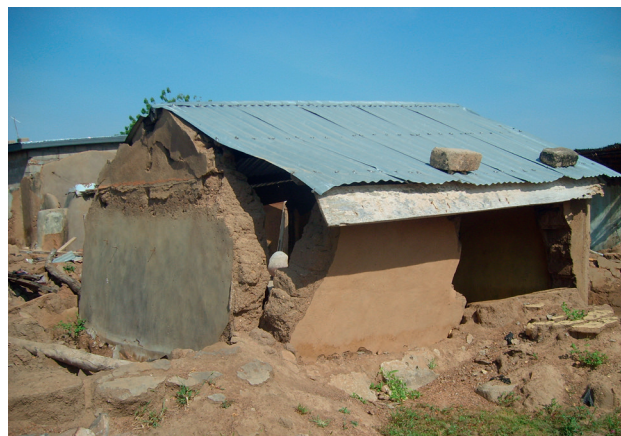
- *Unprotected earth walls bases:* The earth walls that collapsed did not have proper protection such as water resistant aprons. Their protection was in the form of earth heaped around the base to a width of about 500 mm.

- *Damp foundations:* A lot of the settlements in the low lying areas which suffered collapse had damp foundations even during the dry season when visited. Dampened non-stabilised

foundations already constituted a weak point in the stability of these buildings. This meant that buildings were weak even before the floods came.
