Cristina Cazorla Marín, Camilla Mileto, Fernando Vegas López-Manzanares Universitat Politècnica de València, Spain

Earthen architecture: traditional constructions in the fertile lands of northern Valencia

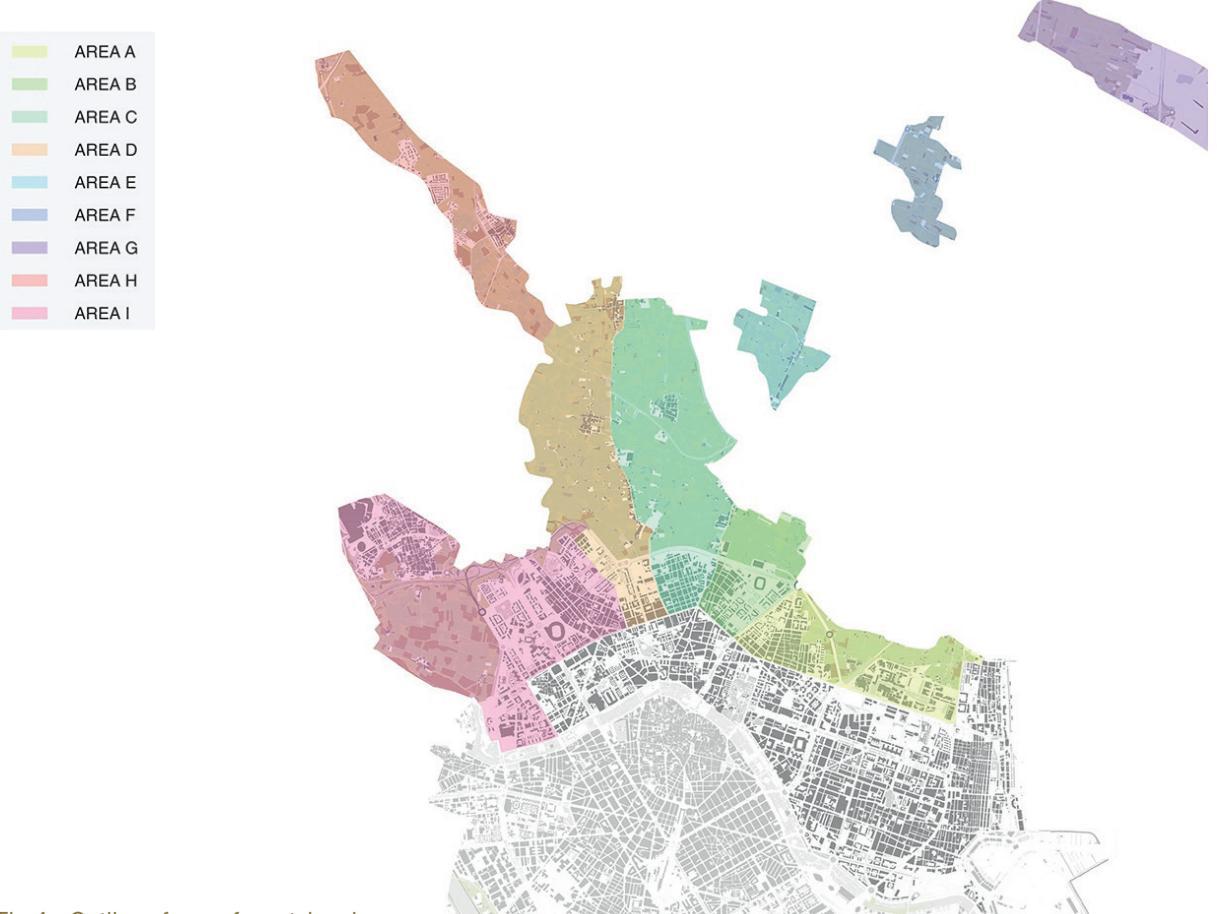
Fig. 1 Outline of areas for cataloguing

Based on a review of the bibliography the earthen constructions found in the land lying on the original riverbed of the river Turia is catalogued in detail (Figure 1).

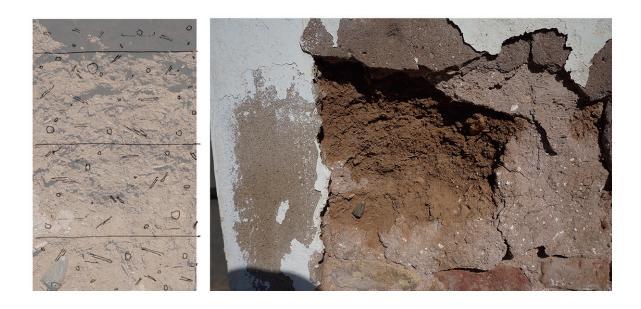
The first of these is the **simple rammed earth wall** (Figure 2). This variant was found in a very small number of cases, in rural homes and mills. The earthen walls themselves are approximately 40 cm thick and the nucleus is composed of earth, some straw to prevent the appearance of cracks during the drying process, and fine aggregate to increase resistance. All the walls studied had an exterior rendering in lime or cement mortar, 1.5 to 3.5 cm thick. The wall surfaces rise from a masonry or brickwork plinth that protects the earthen wall from rising damp; in addition, the corners, jambs and main joins are reinforced with bricks.

Fig. 2 Detail of a simple rammed earth wall

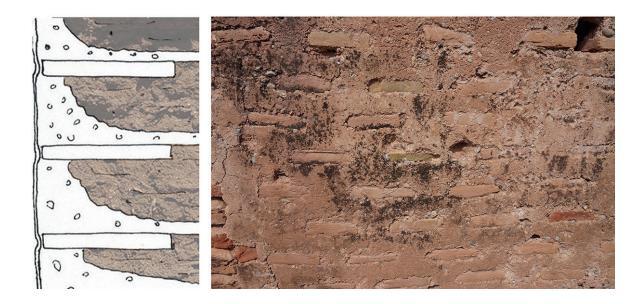
The second variant is a **type I Valencian rammed earth wall** (Figure 3), corresponding to constructions that are 40-52 cm thick, where the tamped mix contains high proportions of earth, lime to provide resistance and fine and/or coarse aggregate. The lime mortar used overflowed during construction to cover part of the more or less regular horizontal brick coursework, with header bonds at a vertical distance of 5-12 cm. Although these do not usually have any exterior rendering, in some cases lime mortar is found, with or without the occasional repair with cement, or with a cement mortar. This constructive typology is found mainly in dwellings although it can also be found in enclosures, mills and constructions built between the 14th and 17th centuries.

Fig. 3 Detail of a type I Valencian wall

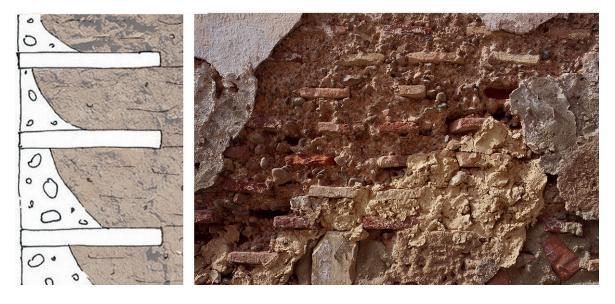
The third variant, **type II Valencian rammed earth walls** (Figure 4), has a lower proportion of earth in the mix than in type I, but has a high percentage of lime and aggregates in different granulometries in the mix. The bricks are laid with header bonds, and the vertical distance between them is 4 to 15 cm. All the cases analysed are currently rendered on the surface with a mortar, either lime or cement, for protection, and in 90% of cases the surface finish is lime mortar. As regards building typology, this type of wall is usually found in dwellings but also in outer walls constructed between the 15th and 18th centuries.

Fig. 4 Detail of a type II Valencian rammed earth walls The final variant, type III Valencian rammed earth (Figure 5) are walls 30-55 cm thick, with a mix composed of earth, lime, brick and fine and/or coarse ag-

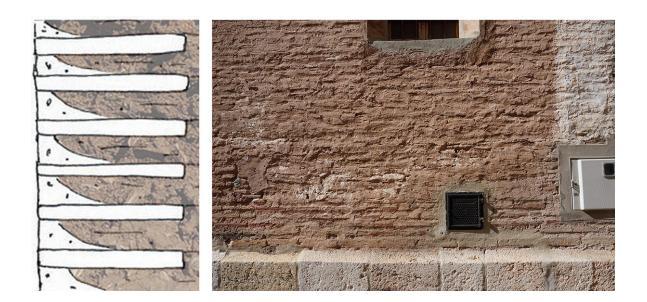
gregate in lower proportions than in the two previous cases. The ratio of bricks in the elevation of the wall is much higher, and the vertical distances between bricks range from 2 to 6 cm, laid with stretcher and header bonds. In terms of exterior rendering, most of these were not rendered or were simply limewashed, although currently many are rendered with lime or cement mortar. As regards general characteristics, most of these constructions were dwellings although there are also auxiliary constructions, mills, or religious buildings dating from the 16th to 18th century.

Fig. 5 Detail of type III Valencian rammed earth wall

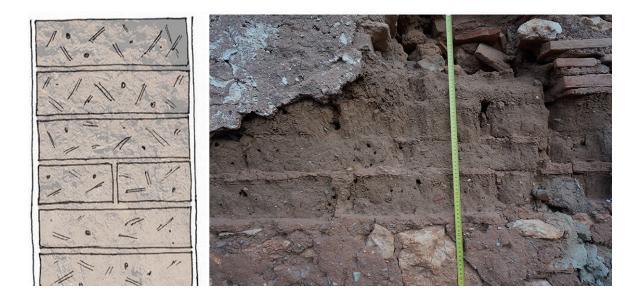
Adobe walls (Figure 6) are made out of earth blocks, large amounts of straw and a small percentage of aggregates – mostly finer – and using the same type of mortar. The constructive cross-section is 44-50 cm, with different types of bonds, in some cases with header or stretcher bonds or a combination of both. These adobe bricks are usually 40 cm long, 20-24 cm wide and 7-10 cm thick. Joins are 1-4 cm. These prismatic bricks are usually rendered in lime to ensure durability, with a plinth to prevent rising damp.

Although this typology was found mainly in dwellings it is also present in auxiliary constructions.

Fig. 6 Detail of an adobe wall

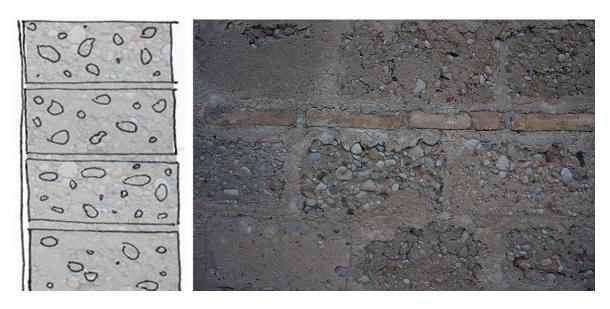
Blocks of binder-earth are widely used in 20th century Valencian architecture. These walls (Figure 7), found in 20th century auxiliary constructions and residential buildings, are 14-40 cm thick, depending on the size and position of the block within the construction. These blocks are made up of a mortar of earth, binders, and gravel of different granulometries in high proportions. The binder may be either lime or cement, and the blocks are laid in the construction in coursework, using lime or cement mortar for the 0.5-2.5 cm joins. Measurements vary greatly as the blocks were manufactured manually: 29-40 cm long, 20-26 cm wide and 11.5-26 cm thick. In terms of bonding we found blocks laid in header, stretcher and header, or in stretcher position, which was the most frequent. These constructions also include horizontally coursed bricks at specific intervals and/or reinforcements at the weakest points of the constructions using the same bricks.

Fig. 7 Detail of a wall of binder-earth blocks

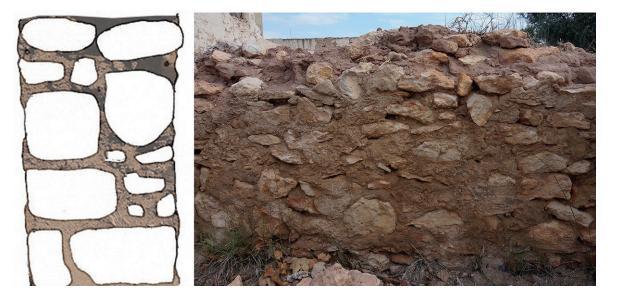
The walls built using earthen mortars (Figure 8) can be found in perimeter enclosures as high as 3 metres and in conjunction with specific types of building and in auxiliary constructions for agricultural and fisheries use.

These walls are 40-44 cm thick. The mortar used is mixed using high proportions of earth, a small percentage of lime as binder and fine aggregate. These are mostly mixed constructions of masonry and brick, or sometimes simply either masonry or brick.

Fig. 8 Detail of a wall with earthen mortar and masonry
